CALSPAN ON-SITE SCHOOL BUS/PEDESTRIAN ACCIDENT INVESTIGATION

CALSPAN CASE NO. 95-14/3

SCHOOL BUS: 1992 INTERNATIONAL CHASSIS/AM TRAN (WARD) BODY

16. Abstract <p>This on-site investigation focused on the root cause of a school bus/pedestrian accident that resulted in fatal injuries to the 14 year old male pedestrian. The accident occurred during the afternoon hours of 1995, near a designated school bus stop. The pedestrian had exited the bus, however, the adjustable tab to the right drawstring of his jacket became caught between the bifold door and the V-channel in which the door closed against along the right B-pillar. The driver immediately accelerated from the bus stop and proceeded in an easterly direction on the narrow one-lane city street.</p> <p>As the bus accelerated, the pedestrian was probably initially pulled as the drawstring remained caught in the door. He reportedly attempted to run along side of the bus and gain the attention of the driver, however, he was subsequently knocked to the pavement as his jacket was pulled off. The pedestrian's right hand swiped along the right side surface of the bus as he fell to the pavement and was run over by the right rear tires of

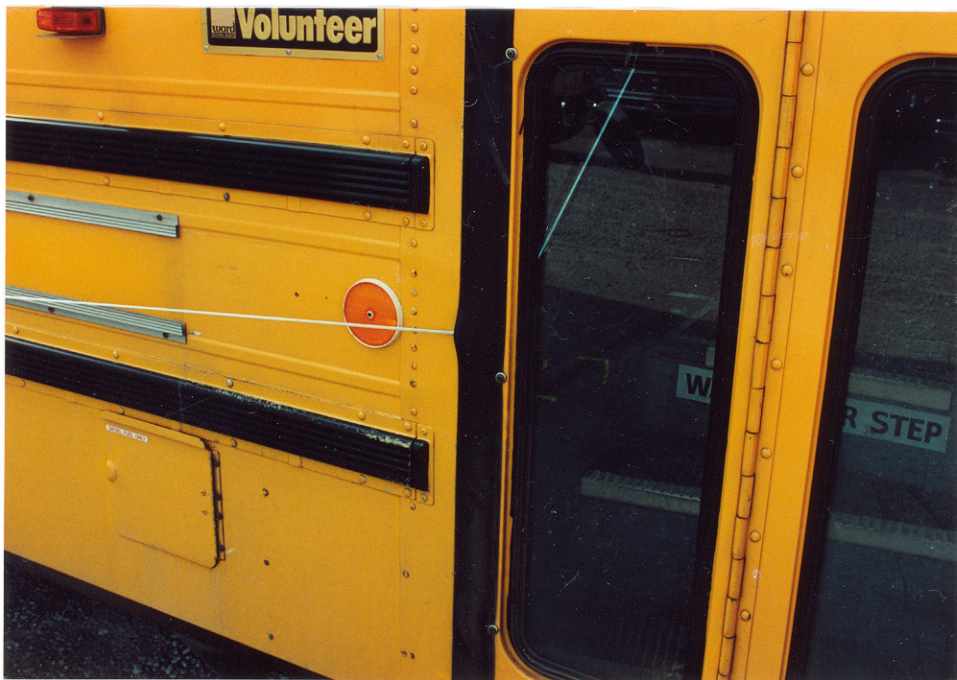
66. Exemplar drawstring extending from door during pull test.

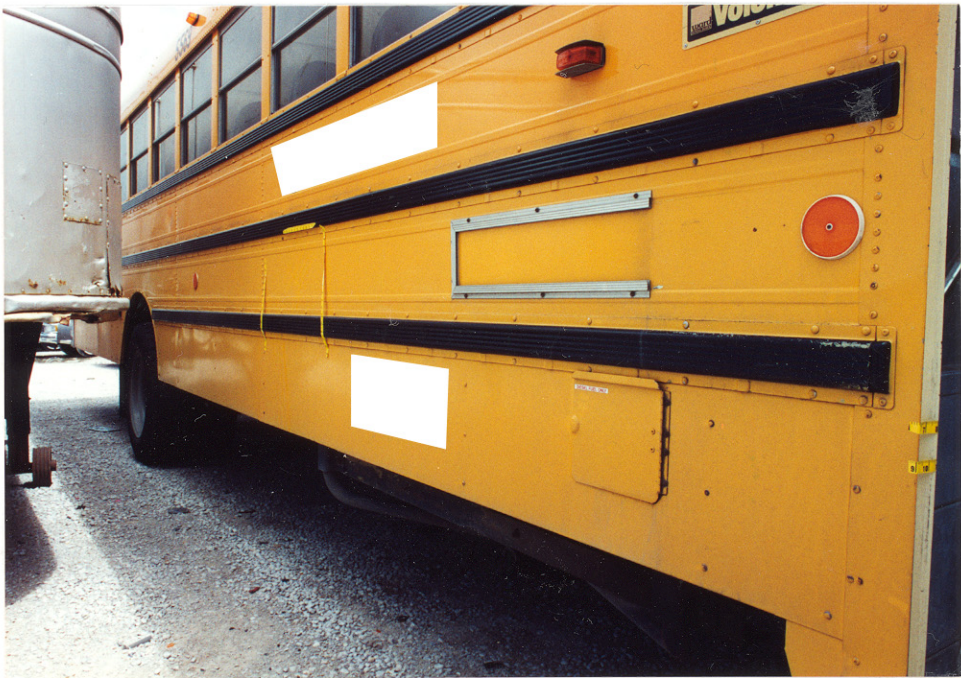
68. Overall view of the right side of the school bus with the pedestrian contact outlined with tape.

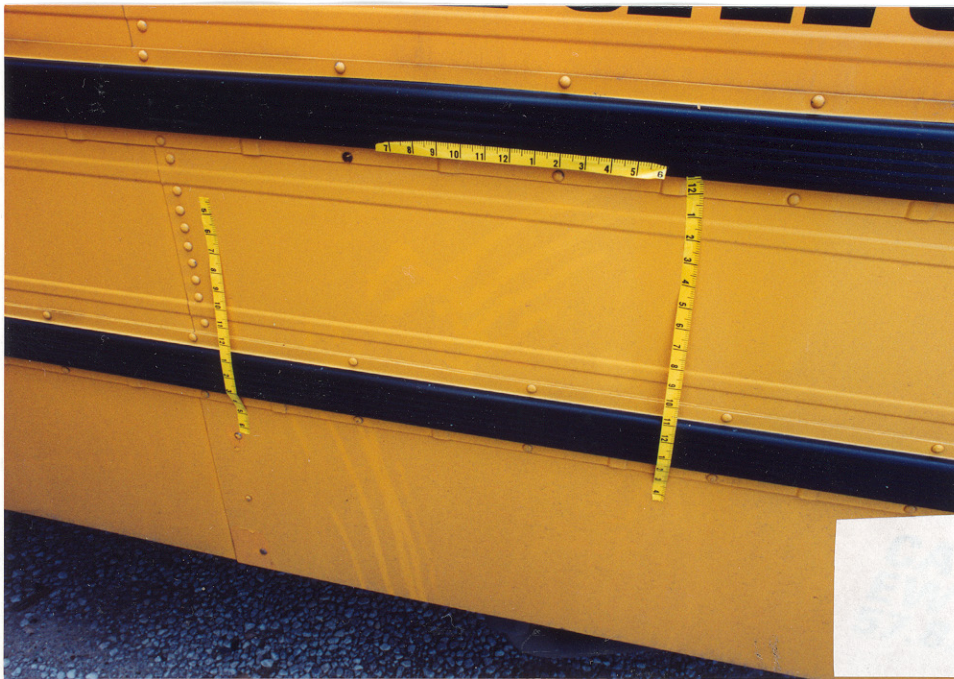
70. Additional view of the pedestrian's right hand wipe mark.

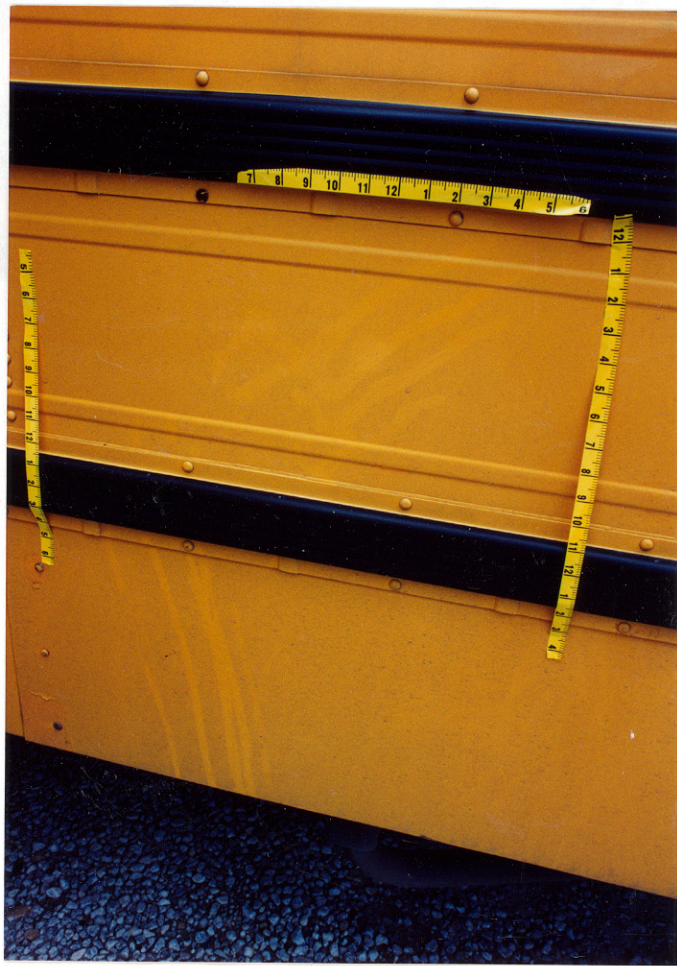
71. Close-up view of the right hand wipe mark.

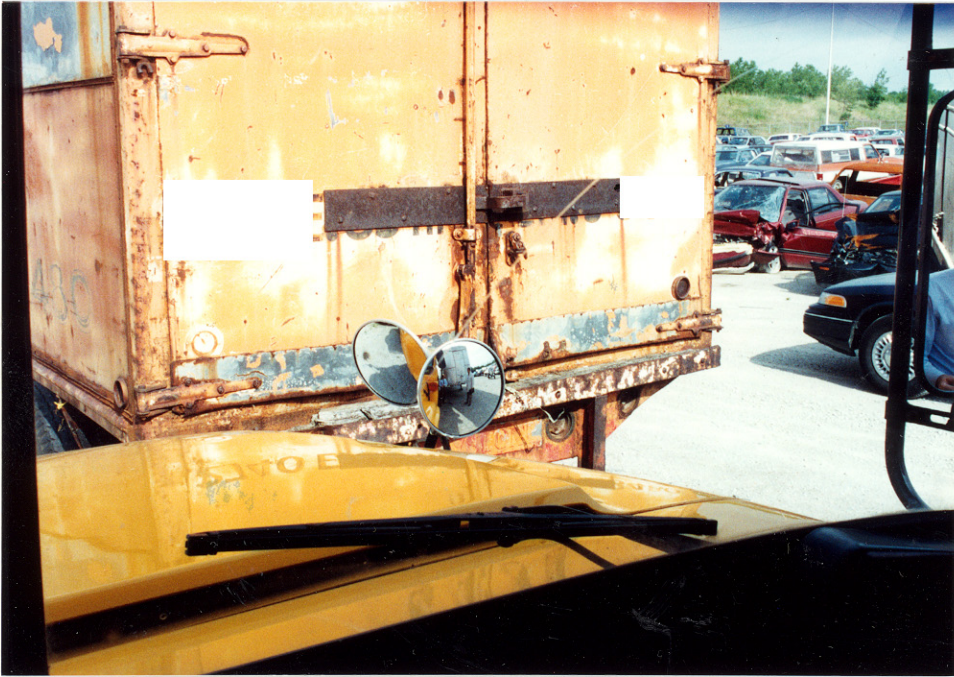
73. Conspicuity of a person standing adjacent to the right B-pillar area of the vehicle in the right convex mirror.

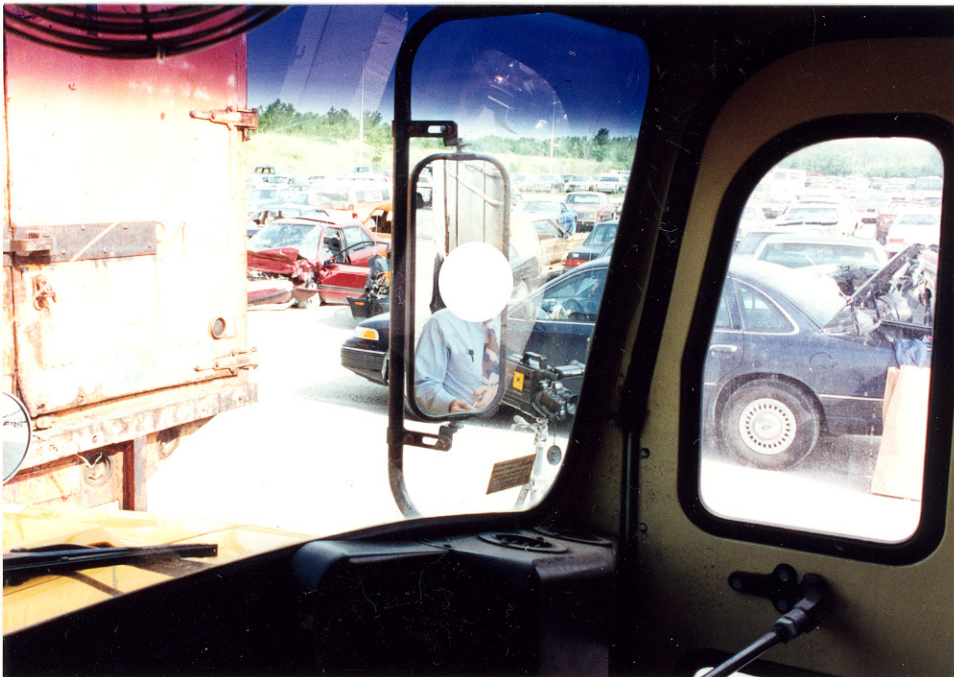
74. Conspicuity of the person adjacent to the right B-pillar in the right rectangular plane mirror.
